LOUIS I. ROTHSCHILD, PH.D., P.E.
FORENSIC ENGINEERING INVESTIGATIONS
858 CHURCH RD. ELKINS PARK, PA 19117
215-887-2106

Re: Dorothy Drout

This report covers my forensic engineering investigation of the involvement of a G.E. Toast-N-Broil (TNB) oven appliance in the fire at the residence of [REDACTED] on December 13, 1988. In performing this investigation, I visited your offices on November 21, 1990 at which time I conferred with Mr. Ralph K. Rosenbaum, Jr. and yourself, preliminarily examined the evidential TNB's remnants, and received from you copies of your existing investigatory file.

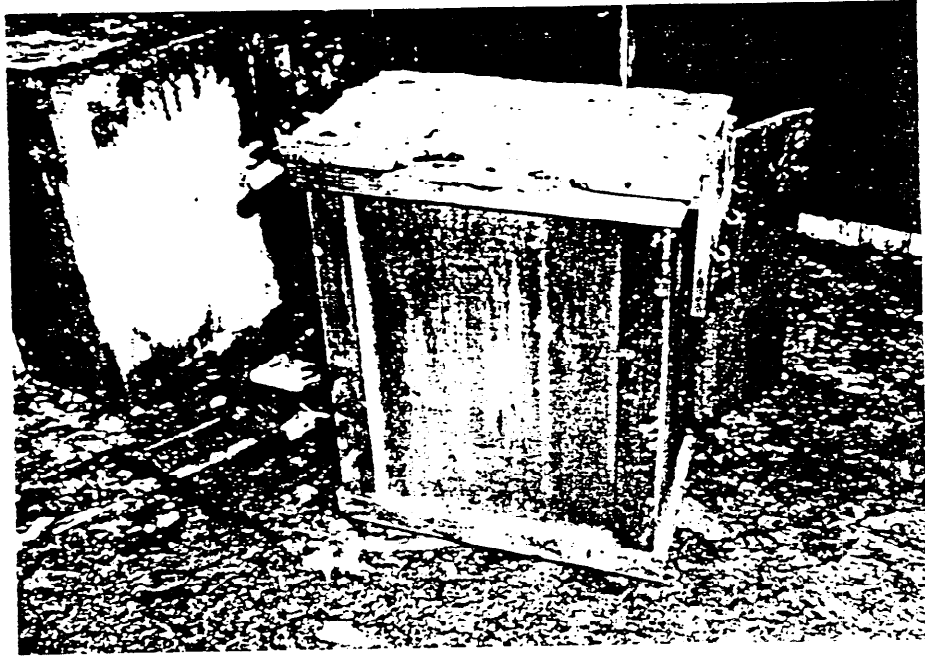
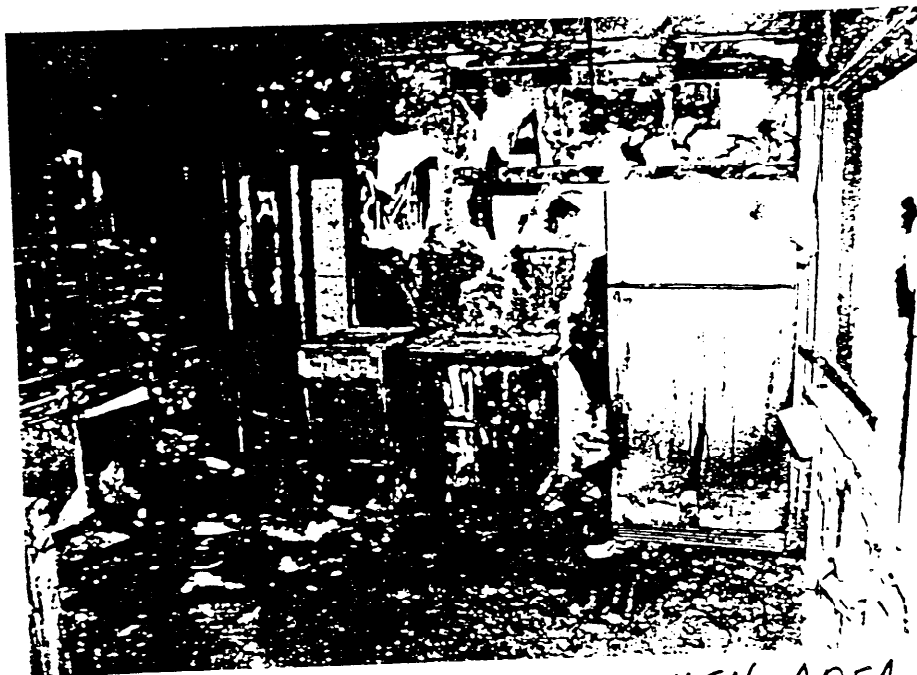
PHOTOGRAPH OF KITCHEN AREA.
TOASTER OVEN KEPT BETWEEN
REFRIGERATOR AND DISHWASHER

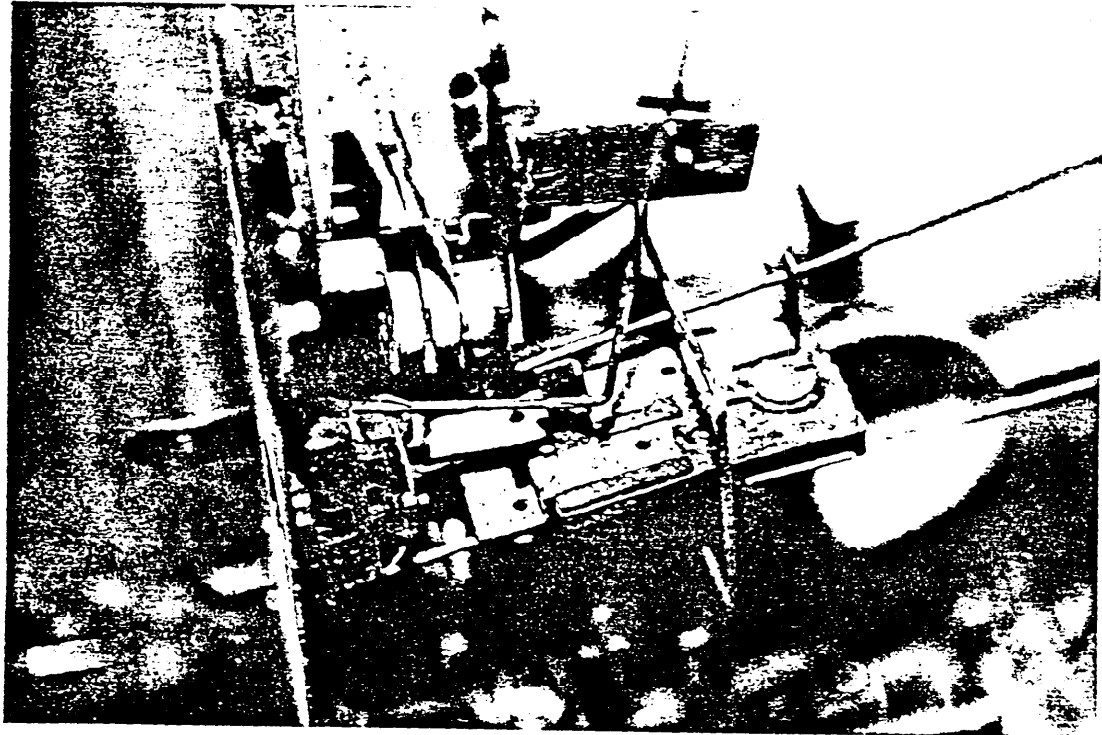
Both the providing of the source for the fire's ignition and the availability of the fuel which could be ignited and spread the fire were due to the defects in the appliance's design. As for the ignition source, the right-hand pair of contacts of the door interlock switch were welded together and its left-hand contact's supporting armature spring leaf was partially melted away. The melting of the latter clearly confirms that it had been subjected to a temperature level significantly higher than could have been attained by the combustion of the flammable materials of the fire. The temperature level required to melt the spring leaf required electrical activity such as results from a defective condition in the electrical circuitry and components of the appliance. The fire clearly originated at

the contacts of the interlock switch which reached a temperature level sufficient ignite adjacent flammable materials.

3.3.1. When leaking into the controls compartment and condensing on the electrical contacts of the bake or toast thermal controls, or on the interlock, they reduce to heavy gummy organic residues which cause thermal controls to malfunction by tending to stick together and result in overcooking and overheating within the cavity. The contamination of the contacts' surfaces manifests itself by pitting and by the brightened points of recently melted metal due to point-to-point arcing between the contacts when they attempt to open.

The the continuation of the foregoing process results in increasing electrical resistance in the pairs of contacts. Since electrical current dissipates heat in a resistance as it passes through, the temperature of the contacts increases proportionally with the increased resistance. Also, contacts will tend to become welded together when they are sufficiently pitted. Thus, the condition of the evidential remnants of the interlock switch contacts is explained.

Close-up views of internal components and contacts found behind oven control dial and toast control lever.

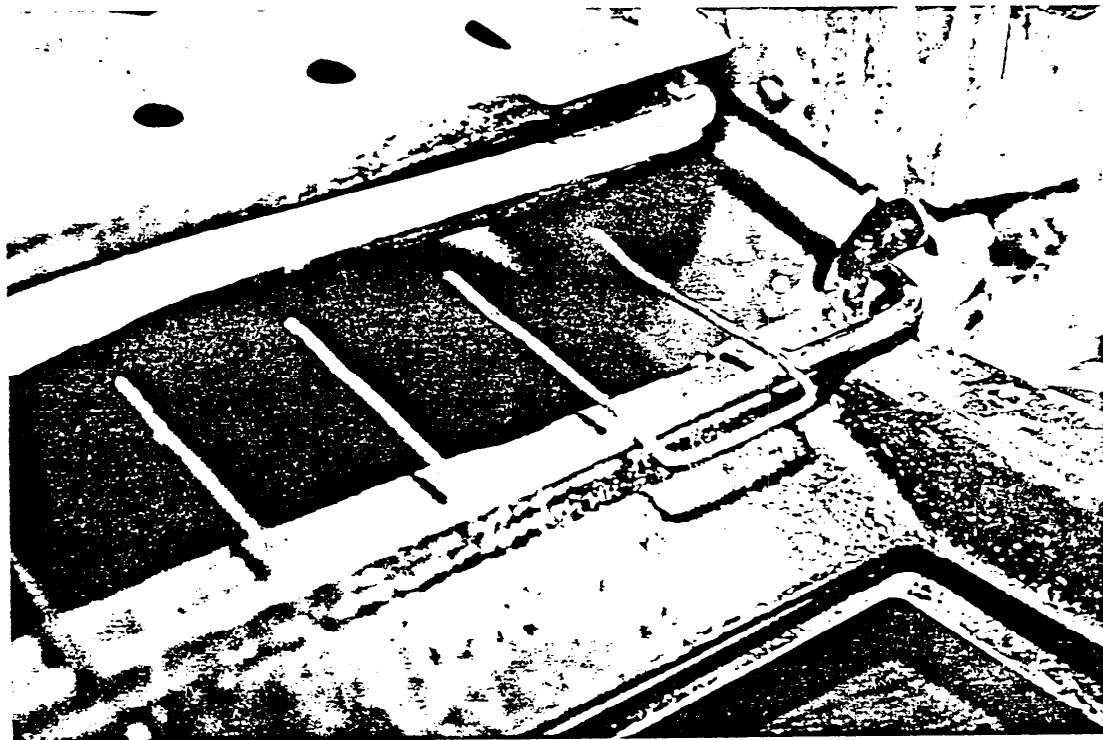
3.3.2. The sealing of the oven cavity from the controls compartment was defective in the following specific manners: facilitated by the opening in the lower right front of the cavity for the rod interconnecting the door and the switch and by the imperfections in the joints between the cavity's right side (which also serves the partition between it and the controls compartment), fats and greases from the cooking processes condensed heavily in and around the interlock switch in the bottom of the controls compartment. Whether, their condensations on the bake-broil contacts or the toast contacts contributed to this fire cannot be determined.

Photo showing grate attachment to door to enable the grate to come out when the door is opened

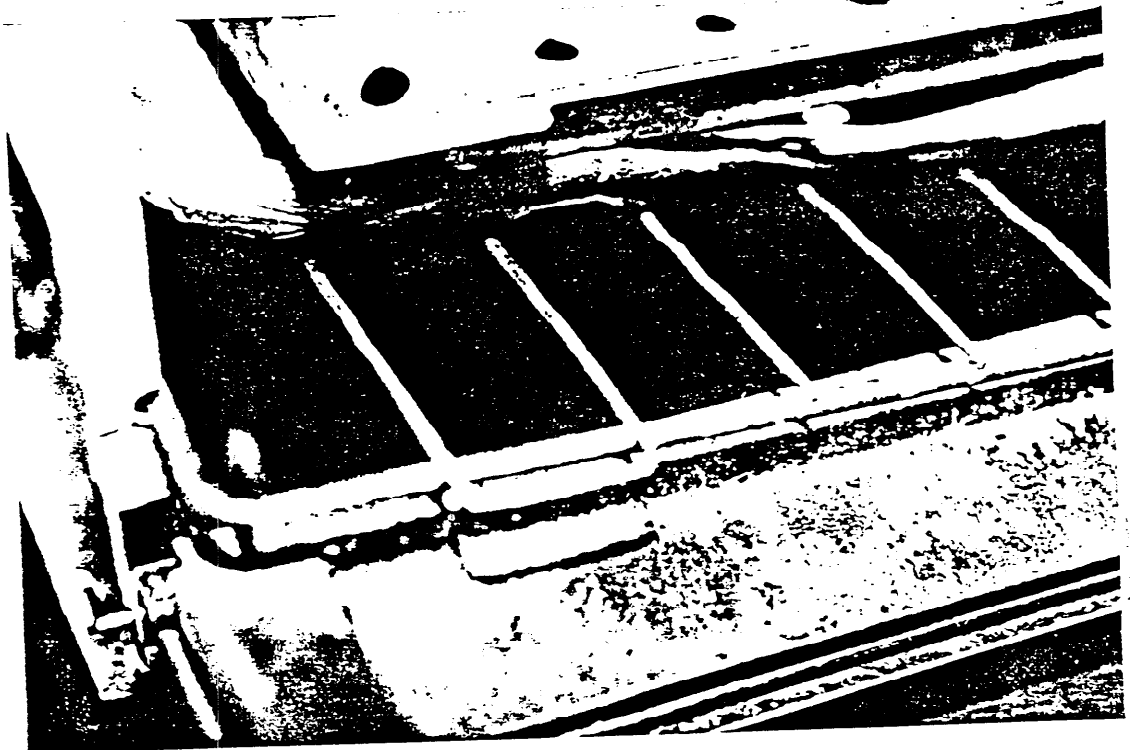
photo of grate with door open

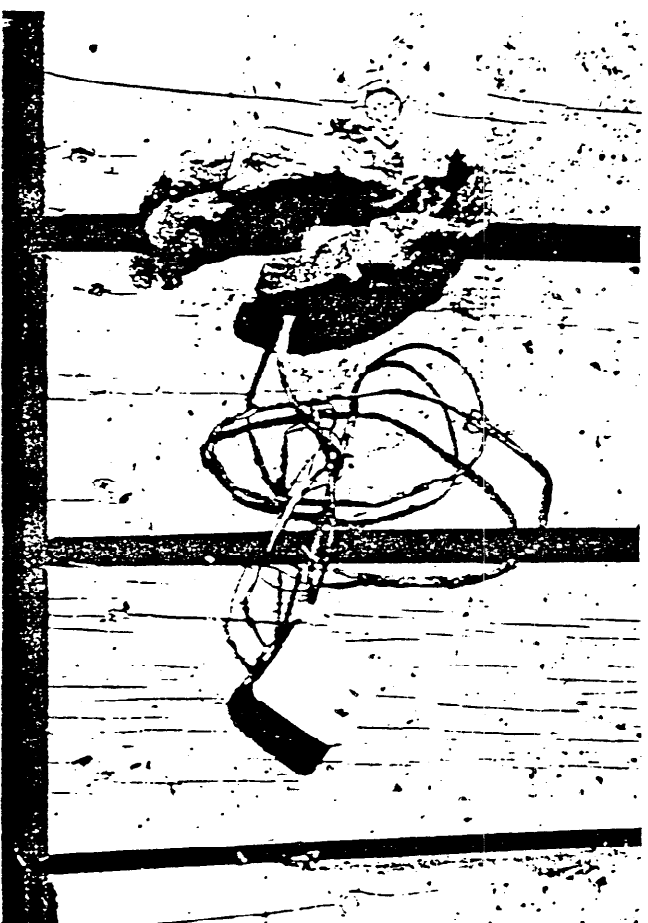
"DUST BUSTER" REMAINS

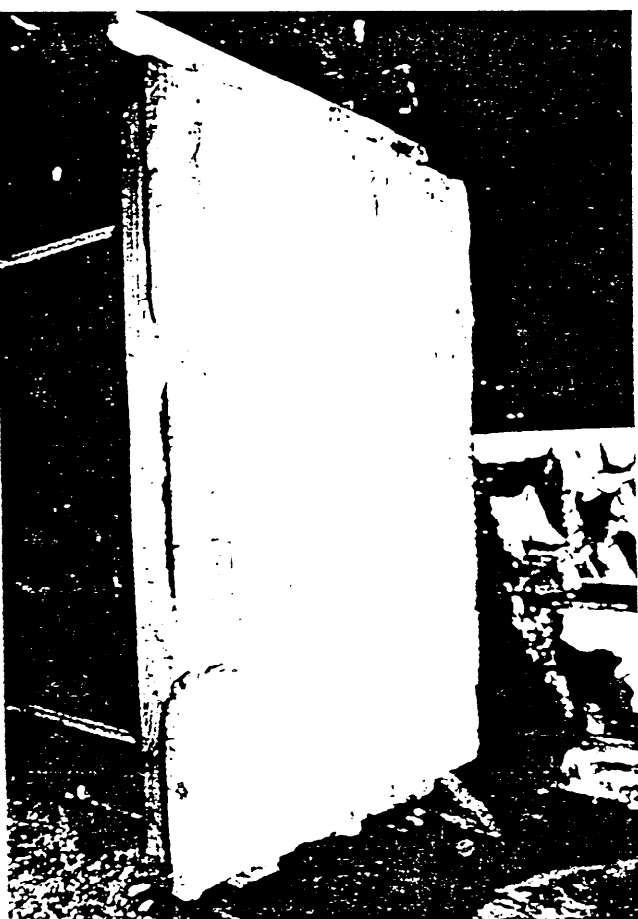
CLOSE-UP VIEWS OF
CART TOP ON WHICH TOASTER OVEN
SAT.
